# Newaukum Valley Road Bank Stabilization

American Public Works Association | Washington State Chapter | 2022 Project of the Year Submittal  
Category: Emergency | Division: Less than \$5 Million

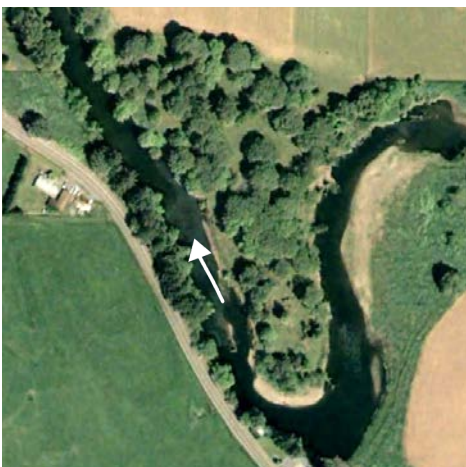
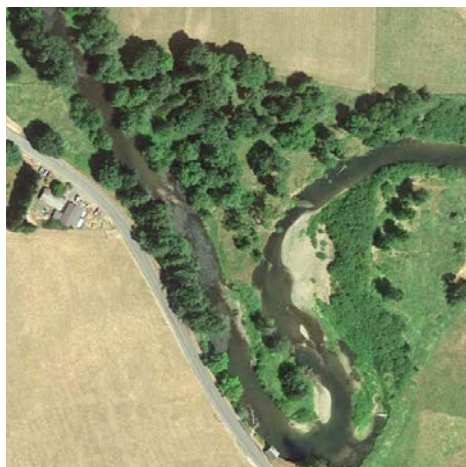
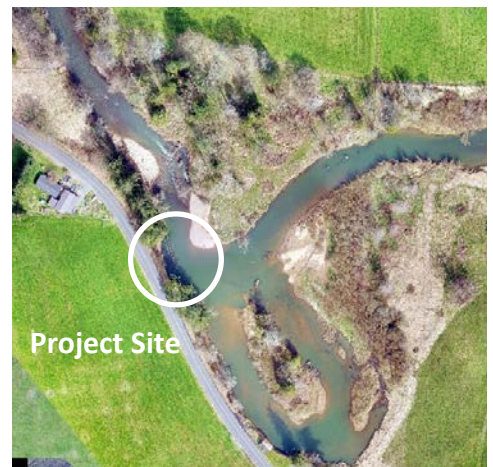
Historical evolution of the Newaukum River bend at the project site in 2009, 2018, and 2021.

The Newaukum River at the project site features a sharp, 180-degree bend that has migrated approximately 95 feet to the west between 2012 and 2019. During the 2019 storm season, the river avulsed and cut off the bend, changing flow patterns along the left bank and beginning erosion towards the roadway. A storm in early 2020 produced high river levels, cutting off the natural bend in the river and resulting in increased velocity of these higher river flows.

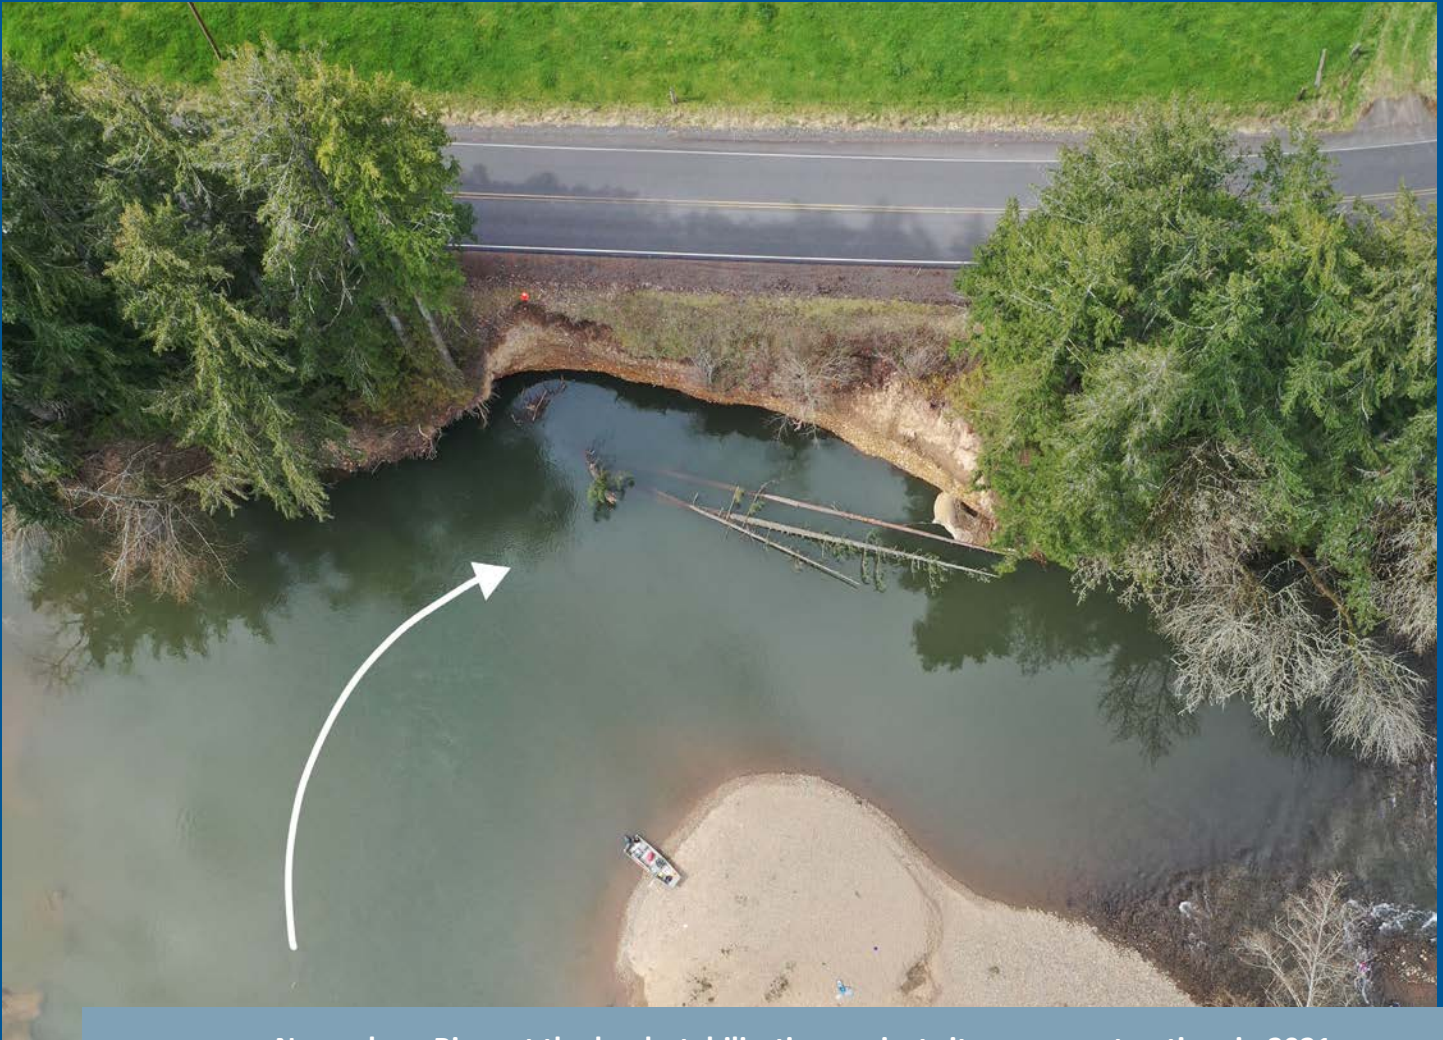
Newaukum River at the bank stabilization project site, pre-construction, in 2021.

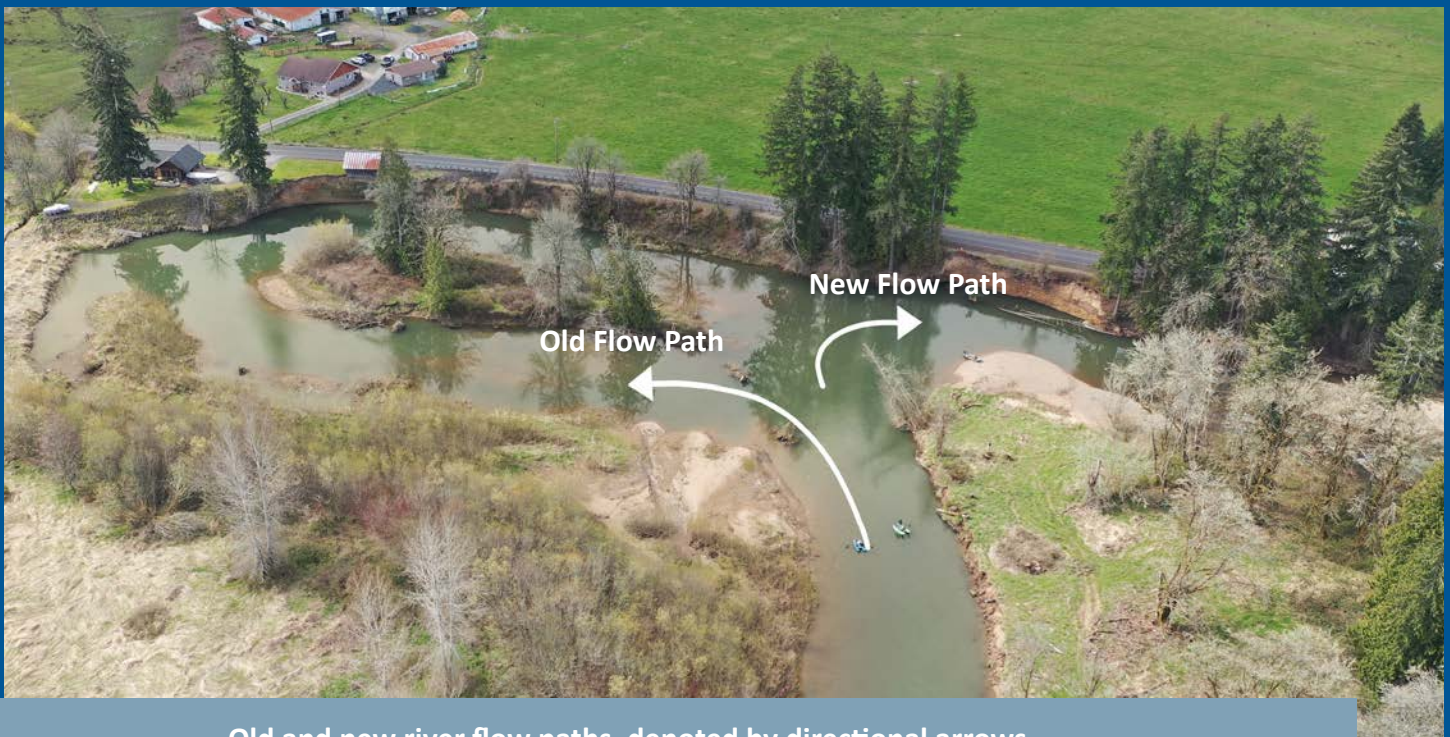
Old and new river flow paths, denoted by directional arrows.

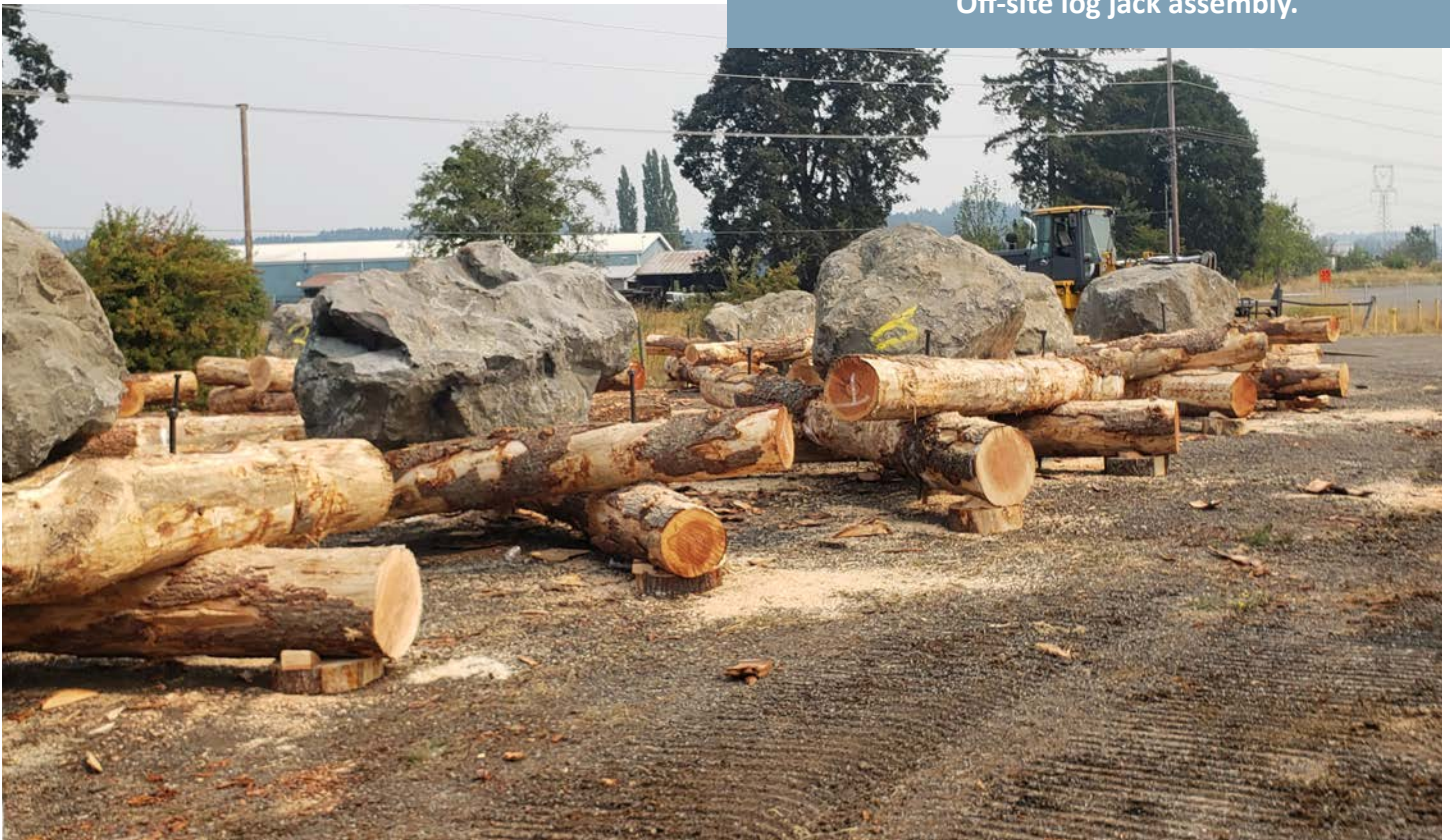
Off-site log jack assembly.

Other key factors in the primary construction and sequence effort was minimizing the amount of time that the crane spent on the roadway and maximizing efficiency in placing the log jacks—reducing site impacts and traffic disruptions. The log jacks were assembled in advance a few miles from the project site in order to optimize installation during the in-water work window. The installation also used a perimeter bubble curtain—placed in the river prior to completion of a full fish exclusion process—which ran continuously from commencement through completion of the in-water work.

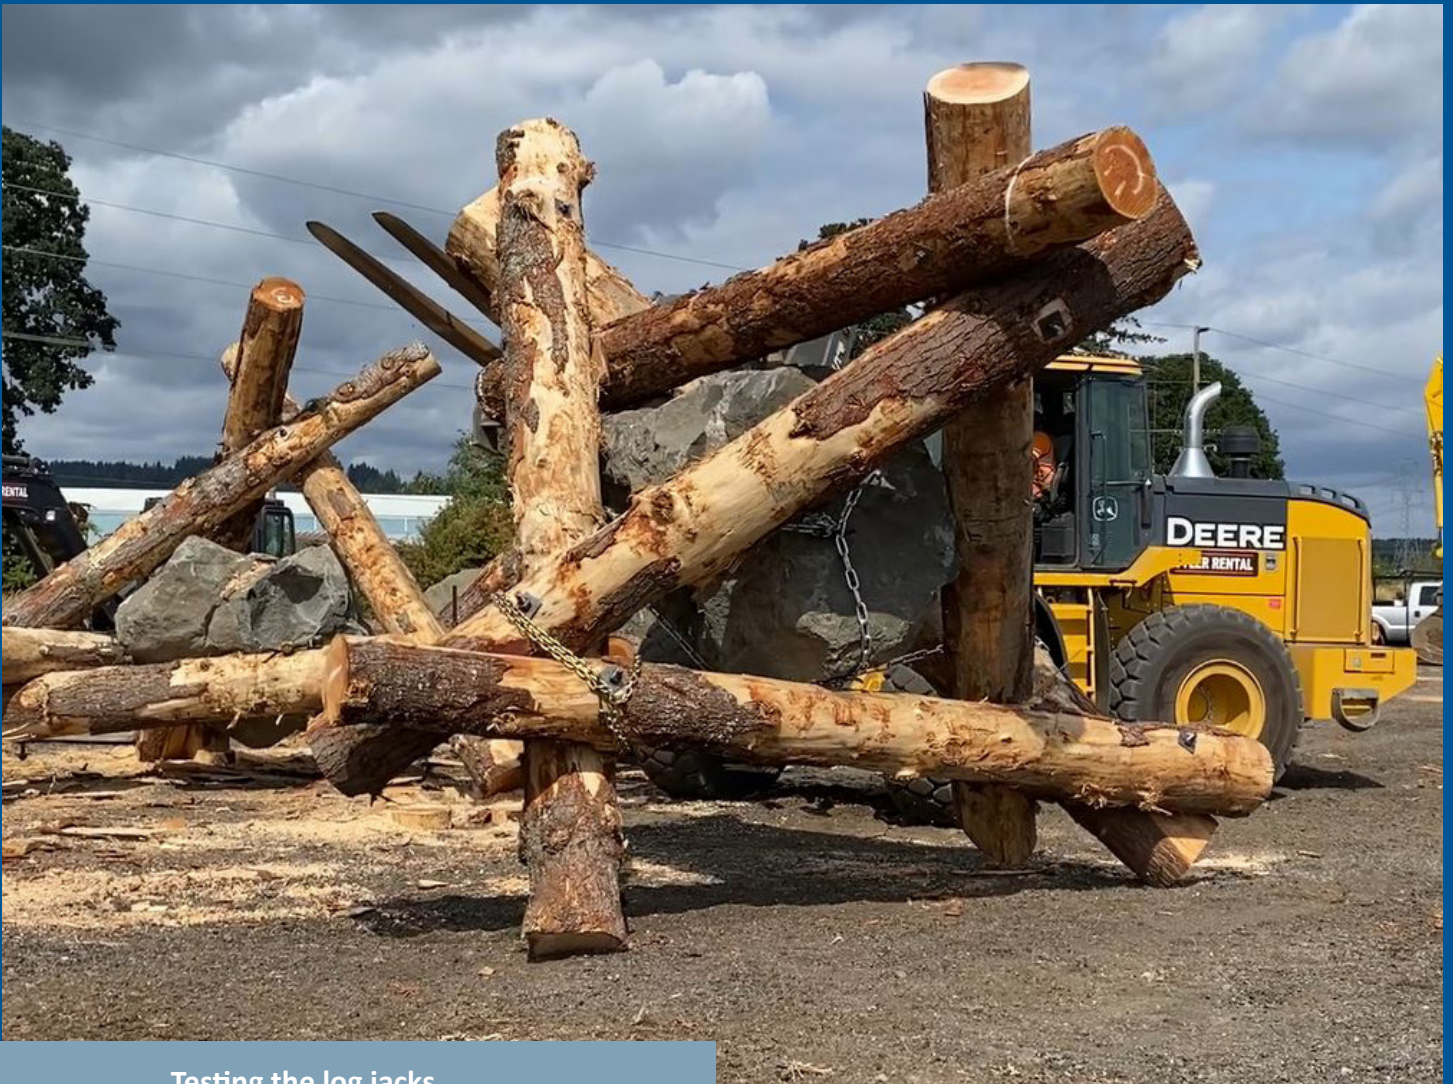
Testing the log jacks.

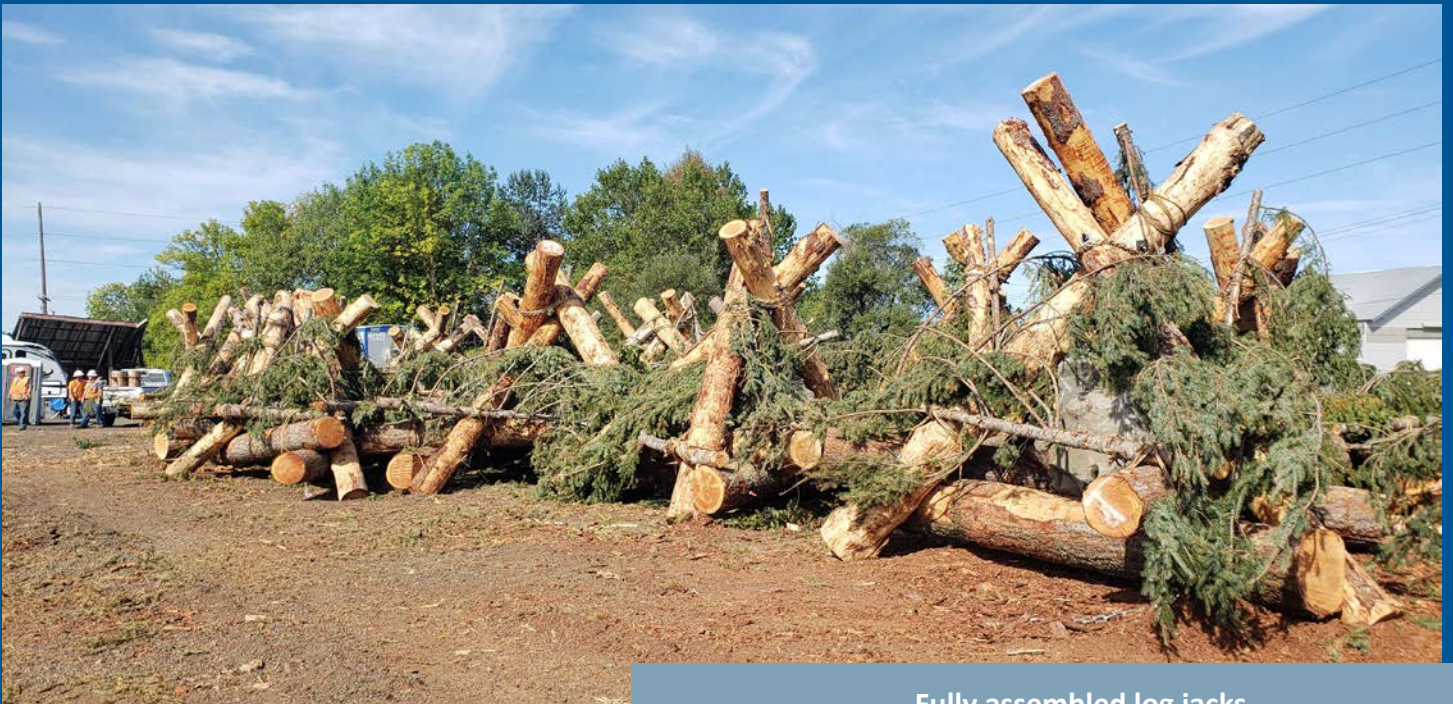
Fully assembled log jacks.

The bank stabilization design consisted of an interlocked system of ballasted log jacks. Ballasted log jacks are individual units consisting of log members connected and ballasted by a single boulder. When installed, the log jack units are placed directly adjacent to or on top of each other to create an interlocked, flexible, wood-based bank protection structure. The log jack design provides and recruits additional natural

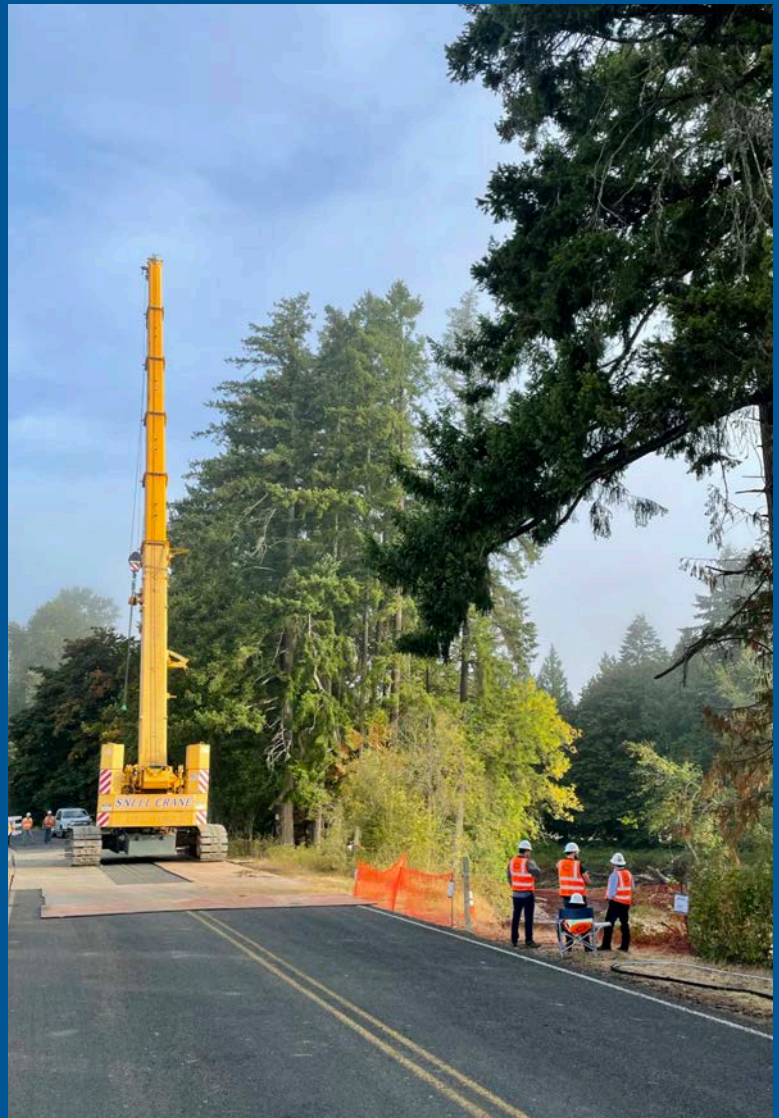
Crane staging during construction.

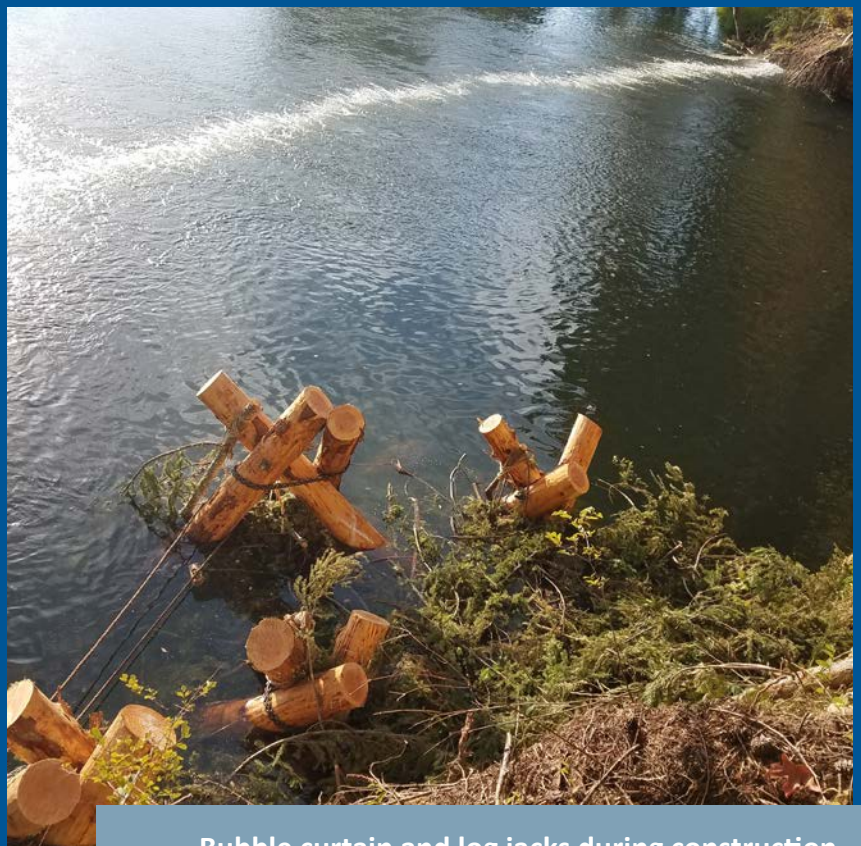
**The bubble curtain provided a deterrent to aquatic species entering the work area during construction.**

**Log jacks protect the river bank and provide protection and habitat for aquatic species.**

Bubble curtain and log jacks during construction.

In-situ placement of bioengineered structures can require dewatering or site isolation, temporarily reducing accessible habitat area and increasing turbidity during construction. Instead, a bubble curtain was utilized. The bubble curtain deterred aquatic species from entering the work area, and installation and removal resulted in minimal in-water disturbance. Additionally, placement of the log jack structures was completed with great care: the jacks were lowered into the water and onto the channel bed slowly, **resulting in near-zero bed disturbances or increases in turbidity.** Overall, the log jack design and the installation method required only 7 in-water work days, minimizing instream impacts.

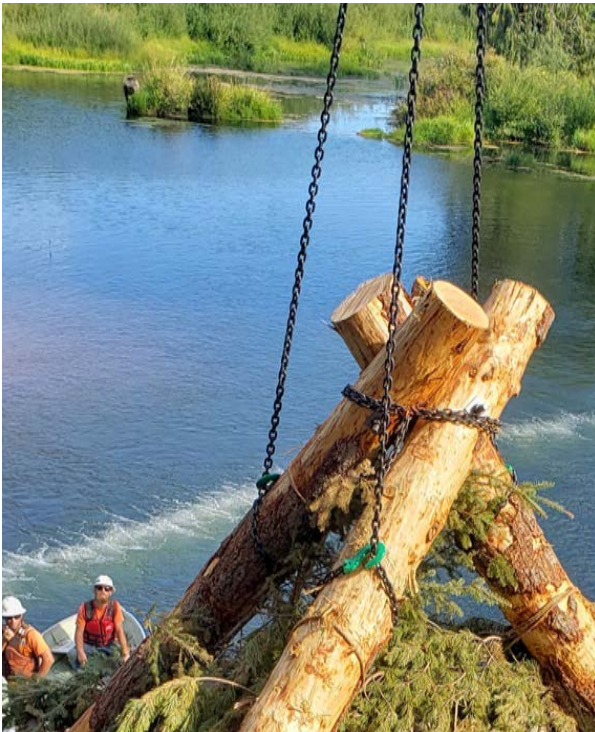
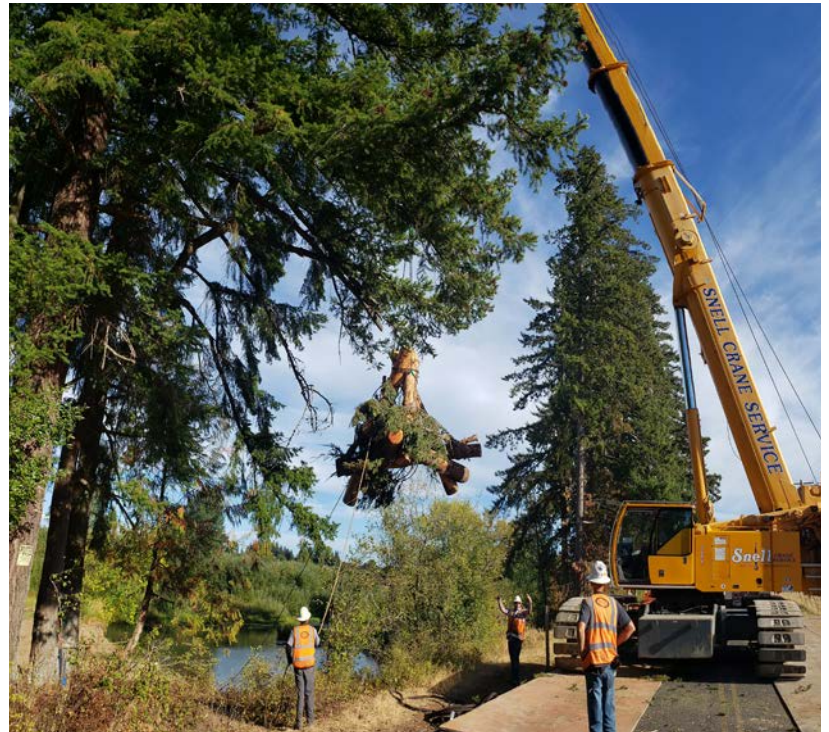
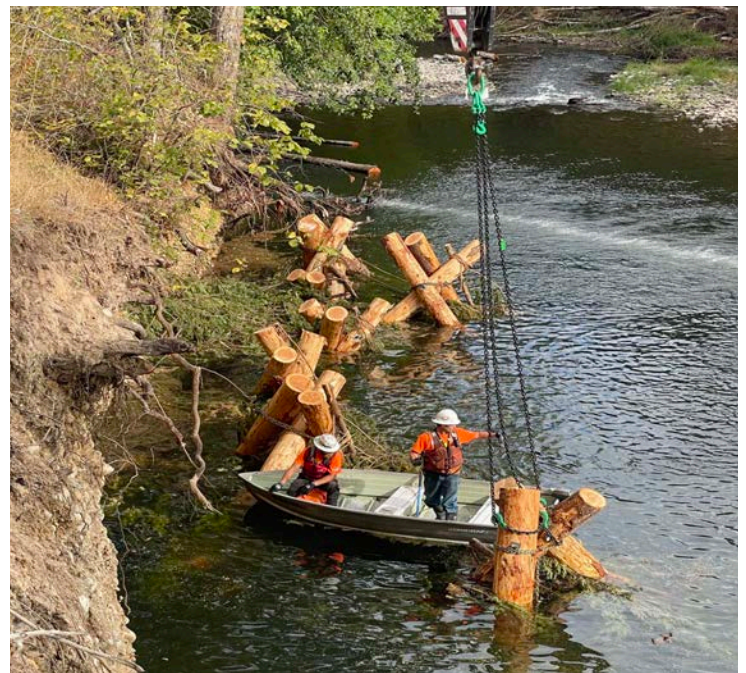
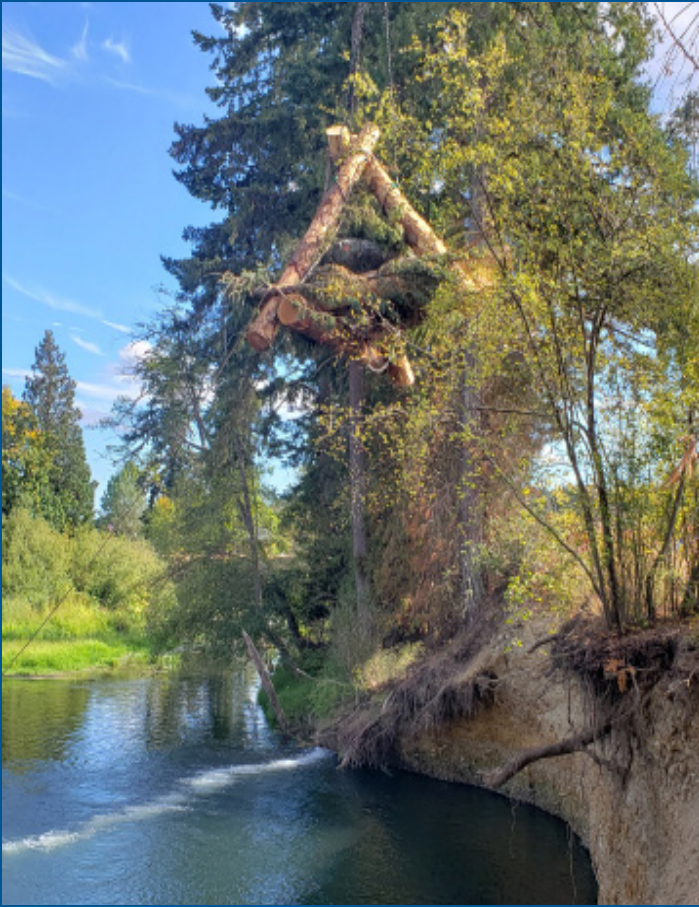
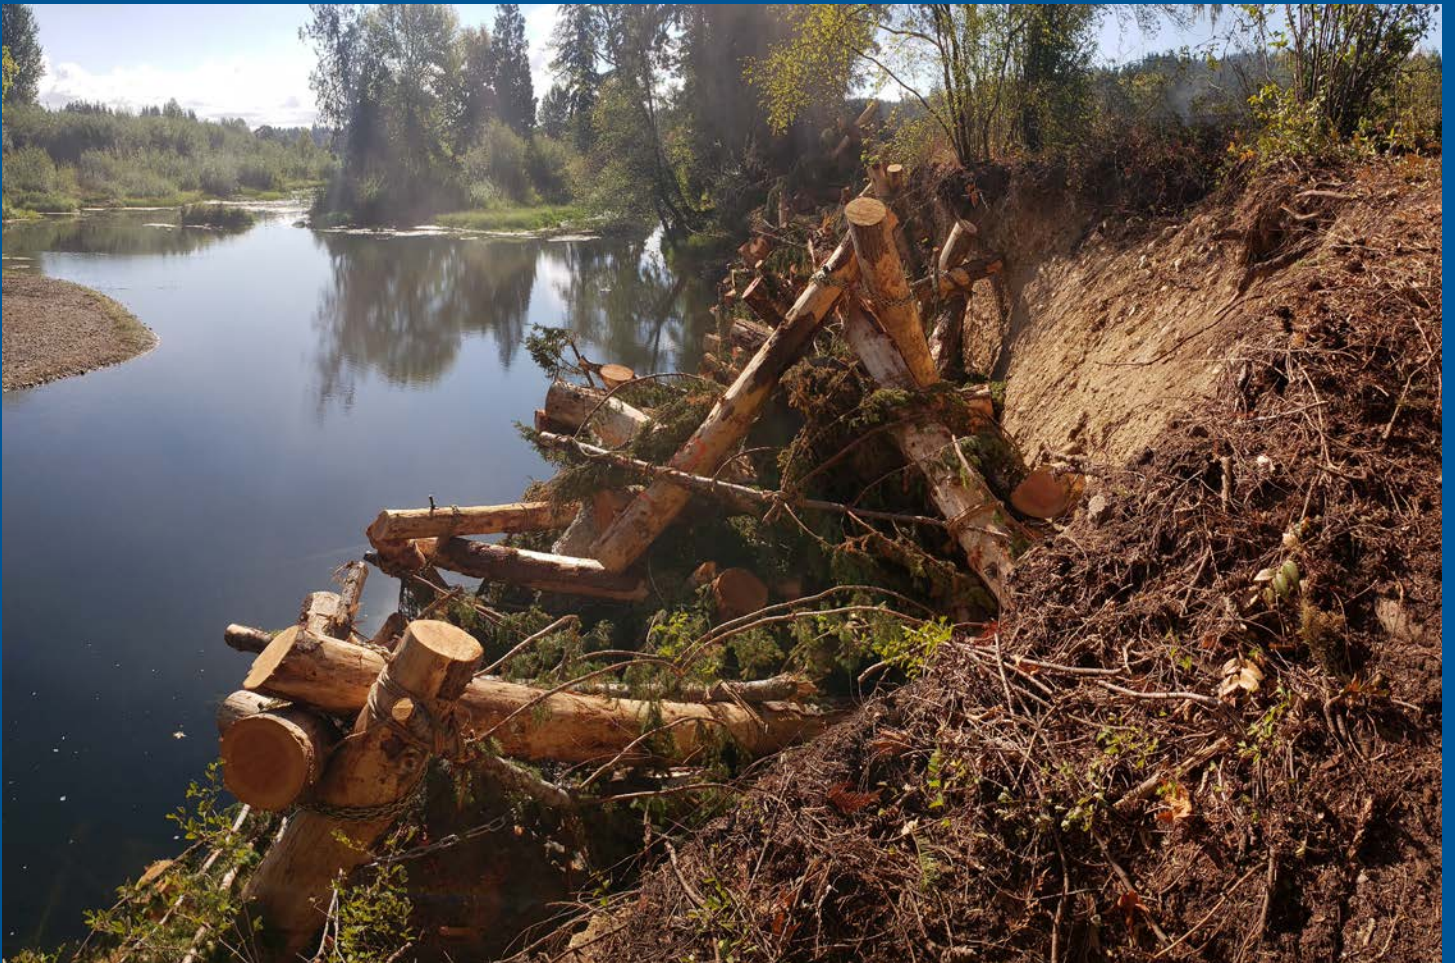
Adverse conditions at the project site included a **near-vertical bank (approximately 30 feet tall) in extremely close proximity to the roadway and water depths of over 10 feet.** Accessing the toe of the slope from the bank or river side would be cost- and logistically-prohibitive, and dewatering or water isolation to install bank protection features in-situ “in the dry” would be nearly impossible. NHC developed a solution that could be built on land and placed in the water using a crane from the top of the bank, thereby minimizing both construction costs and stream impacts.

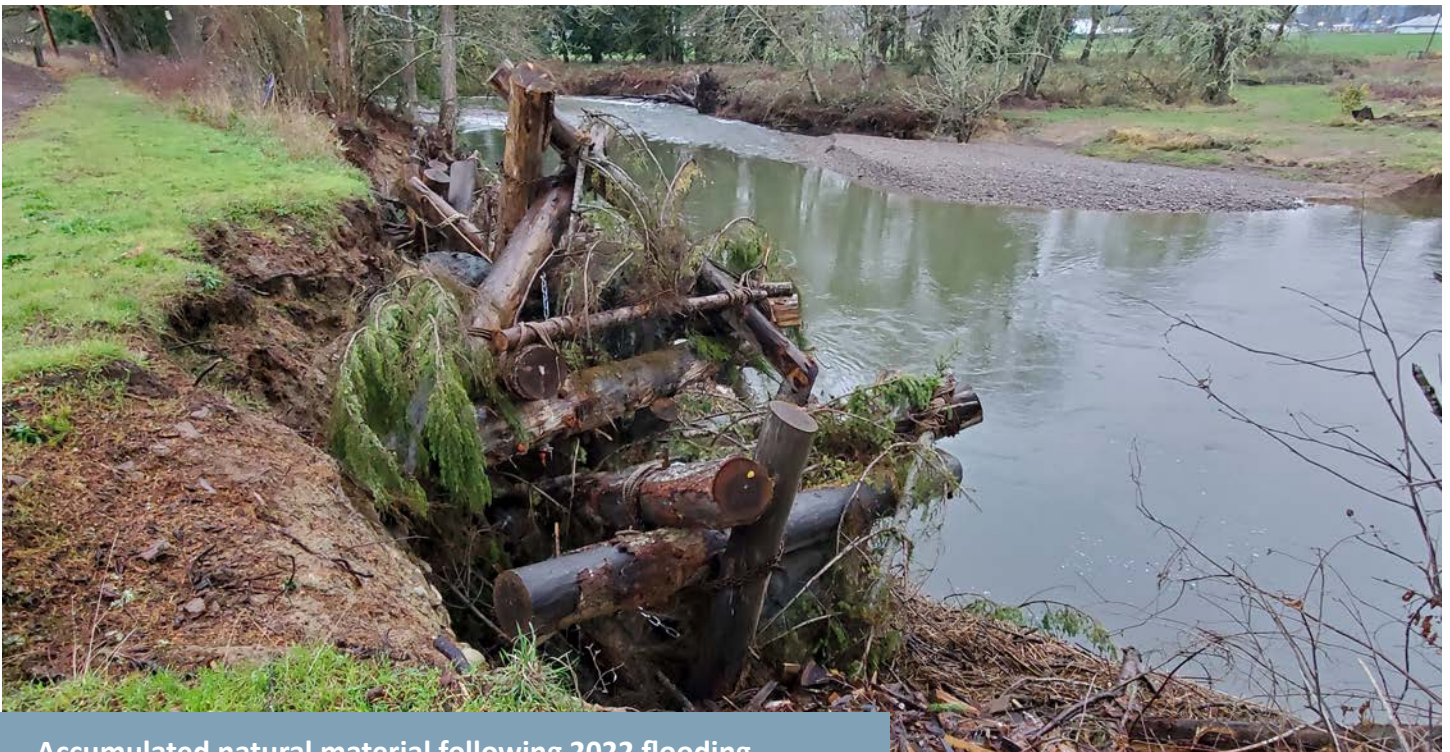
Accumulated natural material following 2022 flooding.

Log jacks tightly interlock during construction to minimize void space while increasing bank roughness and providing valuable aquatic habitat. As the river naturally transports sediment and debris, those materials will settle into the lower velocity zones within the jacks, collecting natural materials and providing future protection to the vulnerable bank.
